Mike Freisthler
Asphalt Systems Inc.
2150 W. Michigan St
PO Box 232
Sidney, OH 45365

Tuesday, December 20, 2011

RE: ASTM D6433-03 Inspection Study – Requarth Rd., Darke County

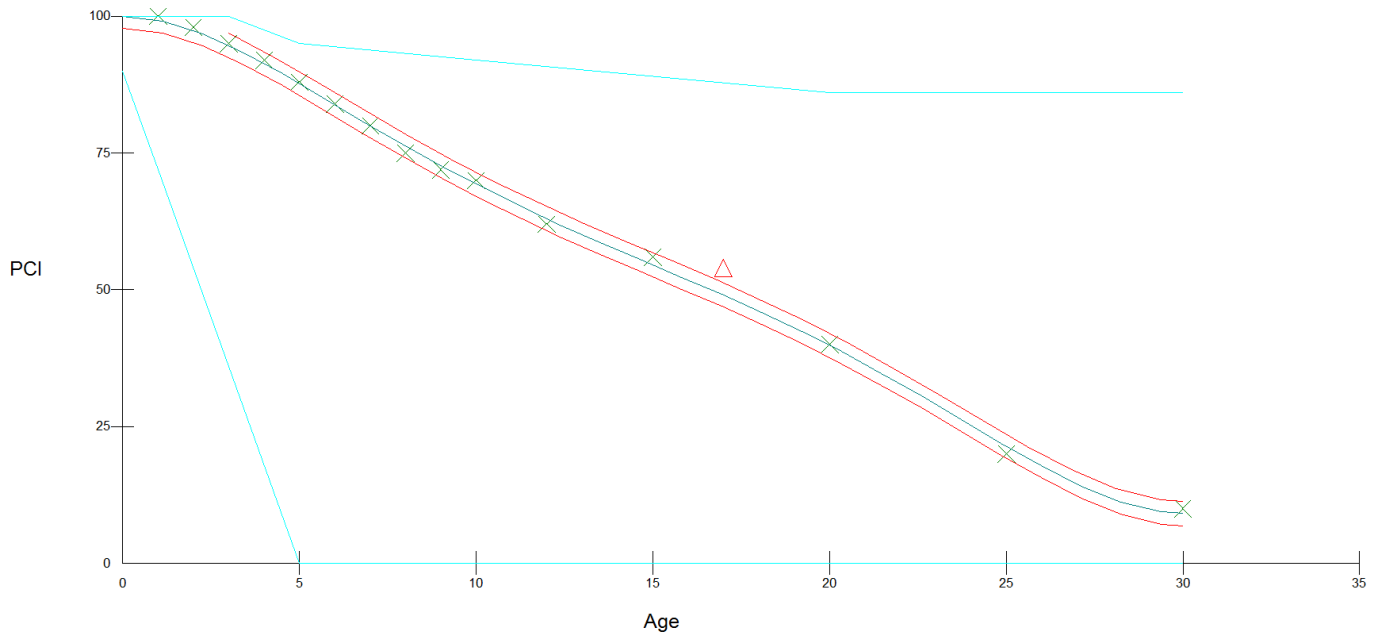
TREATED

In comparing the 2 pavement sections through the ASTM PCI evaluation it has been determined that the section treated with Biorestor is at a much slower rate of deterioration vs. the section that was not treated. The PCI difference between these two sections is at 11 PCI points. When looking at rates of deterioration, the section treated with Biorestor is dropping on average just 3.6 points per year while the non-treated section is at a 5.1 PCI point drop per year.

The following deterioration curves were developed based on pavement age, maintenance and inspection data to show performance/life expectancy of the treated vs. non-treated sections:
