RE: ASTM D6433-11 INSPECTION STUDY – REQUARTH RD, DARKE COUNTY

SUMMARY

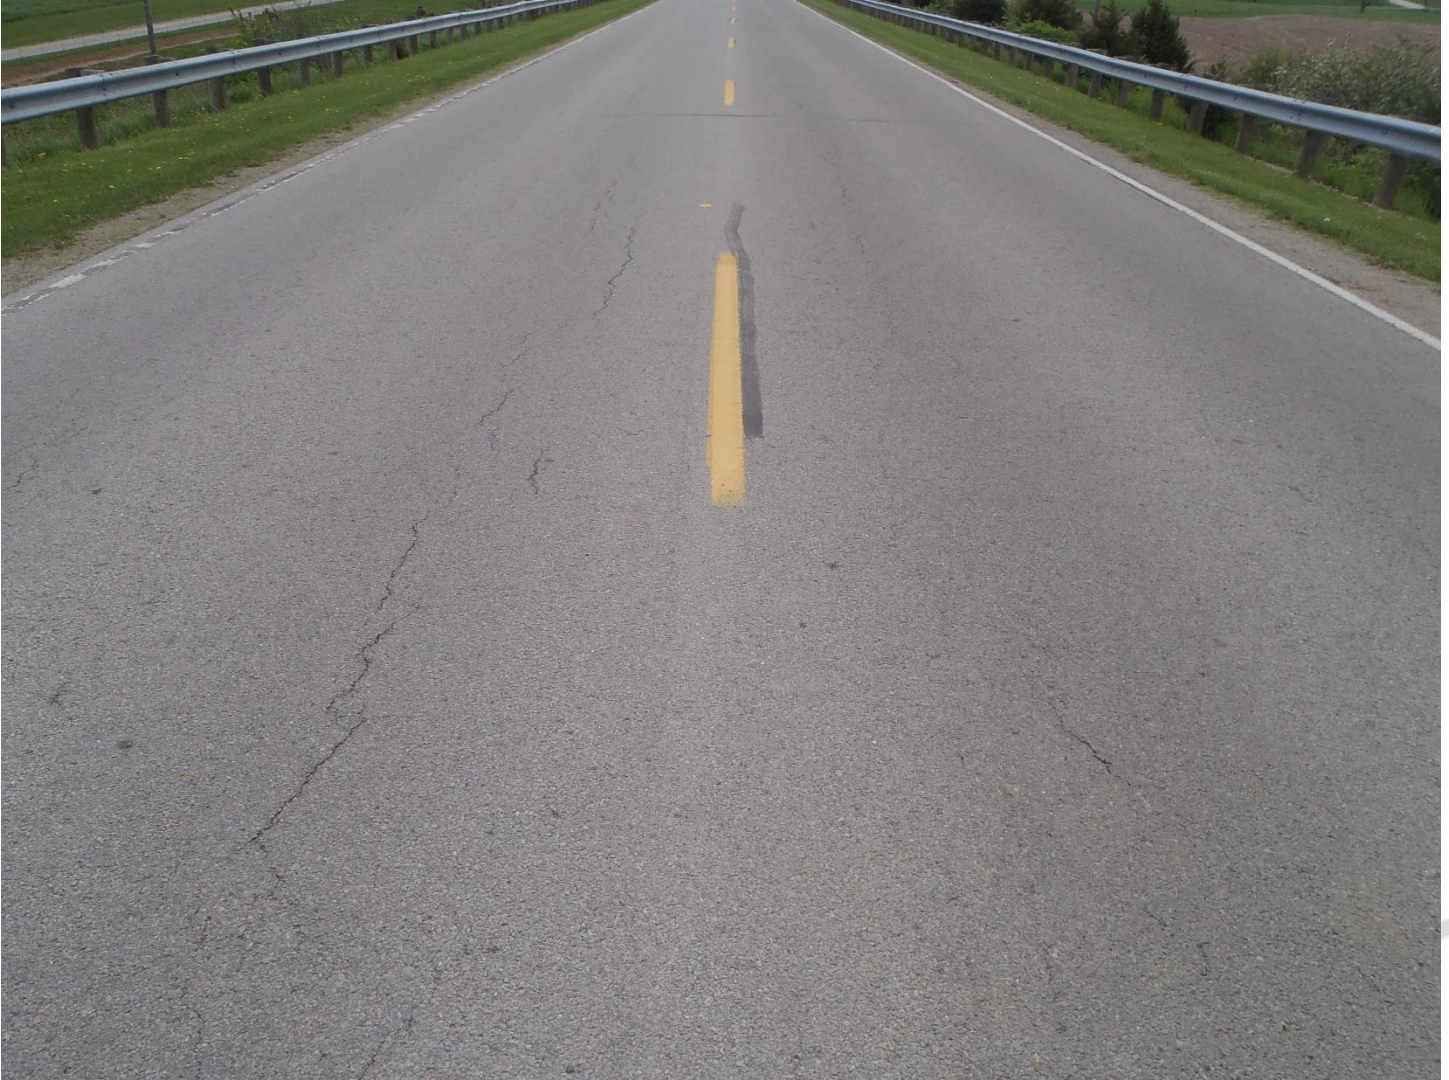
Treated:

Image clearly shows lighter weathering, longitudinal cracking and alligator cracking

In the case of the treated section, alligator was just beginning to develop as fine hair line thin cracks located within the wheel paths of the section, and occurring in a start/stop pattern. In the non-treated section, these cracks were beginning to open approximately $\frac{1}{4}$ " in width with a network pattern developing moving from the light severity level to the medium severity level. Because alligator cracking is a load associated distress it has a high deduct value highly contributing to the 8 point difference in PCI between the treated and non-treated sections.

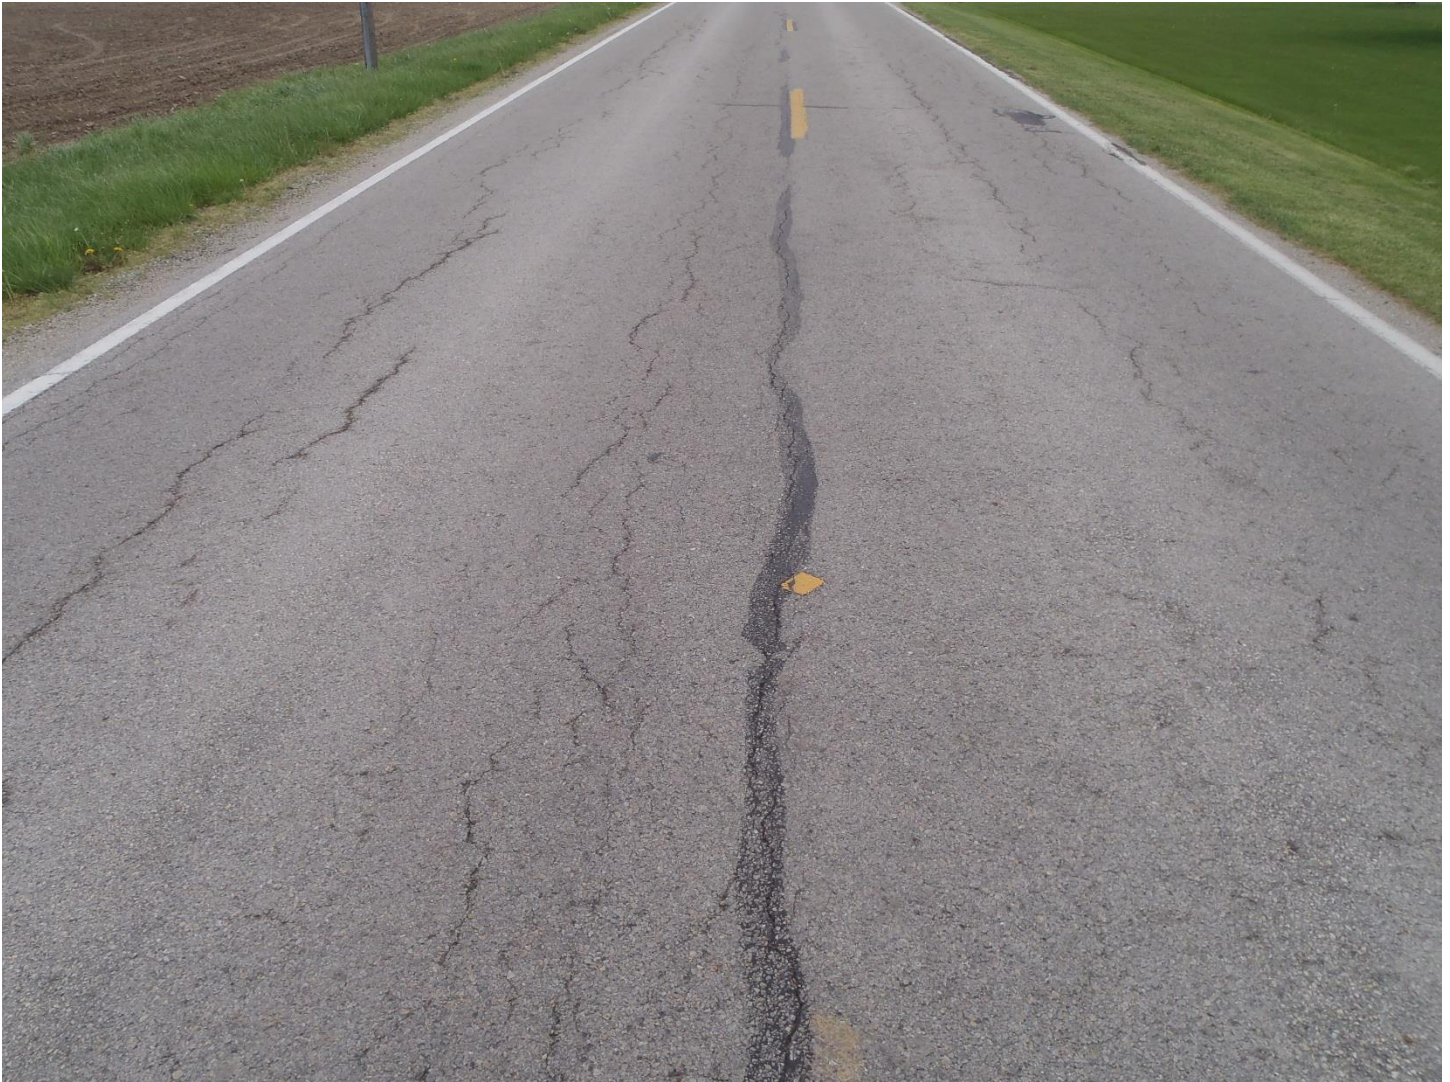
Not Treated:

Image clearly shows accelerated weathering, further defined and development of longitudinal cracking and alligator cracking

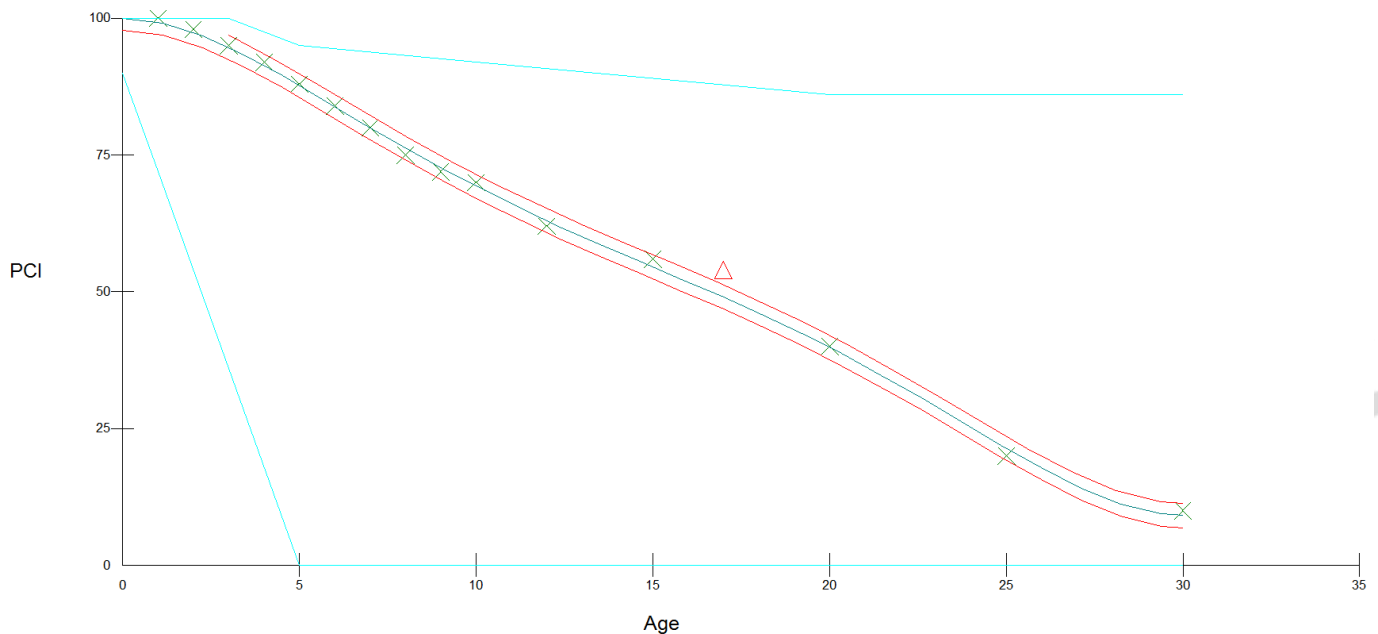
TREATED

The following deterioration curves were developed based on pavement age, maintenance and inspection data to show performance/life expectancy of the treated vs. non-treated sections:
